**SEATTLE CITY LIGHT WORK ORDER #90-6**  
**1990 SPRING MONITORING OF THE GEORGETOWN FLUME**

**Raven Services Corporation**

September 13, 1990

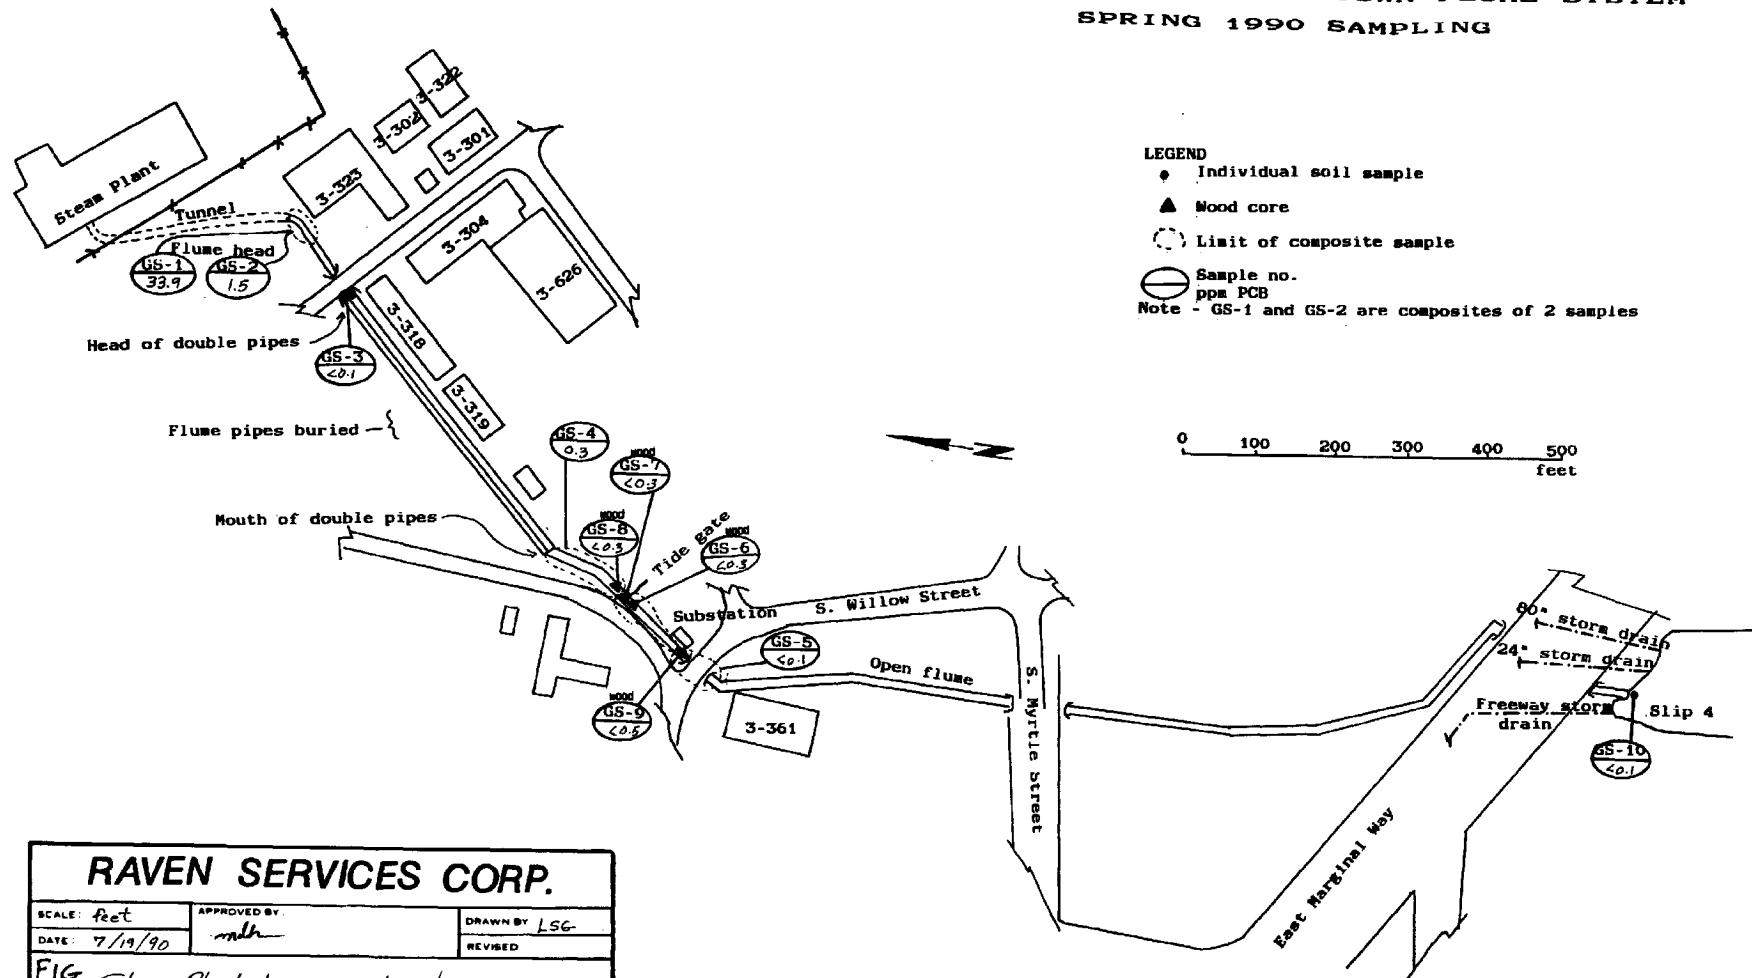
RAVEN SERVICES CORP.		
SCALE: feet	APPROVED BY: <i>mlh</i>	DRAWN BY: LSG
DATE: 7/19/90		REVISED:
FIG 2 Steam Plant & Flume Locations		
SEATTLE CITY LIGHT		DRAWING NUMBER: 90-601-2

The PCB results are listed by Aroclor in Table I and PCB concentrations in the flume are shown in Figure 2. One composite sample from the flume head near the tunnel entrance contained 33.9 ppm; near the mouth of the flume head, 1.5 ppm was found. In the composite of four subsamples above the tidegates, 0.3 ppm was found. The other composites including the Slip #4 sample displayed no detectable PCB signals. The wood cores also displayed no detectable PCB signals.

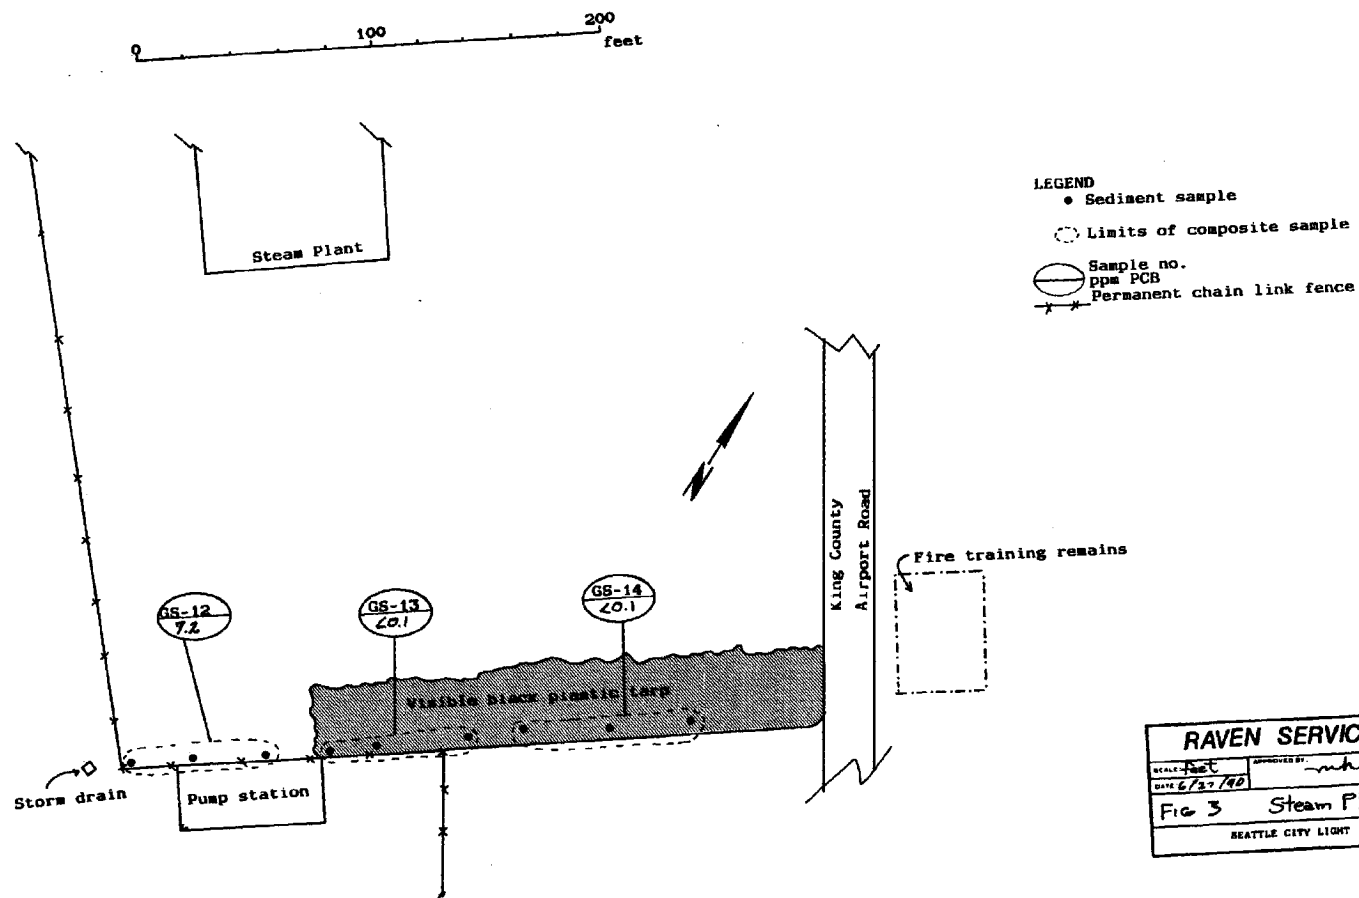
RAVEN SERVICES CORP.			
SCALE: Feet	APPROVED BY: <i>mh</i>	DRAWN BY: LSG	
DATE: 6/27/90	REVIEWED:		
FIG 3 Steam Plant Yard			
SEATTLE CITY LIGHT			90-601-3

Soil and sediment samples gathered in the Steam Plant yard for this monitoring period are also listed in Table I. The sample locations are plotted in Figure 3. Of the three composites collected, only the site of the old catch basin contained sediments with detectable PCBs (7.2 ppm). A physical description of all the samples in this study is provided in Table II.
